Fannin-Lehner Preservation Consultants have completed four very busy and productive days at Ancient Cemetery. After accessing sixteen of our endangered stones, they were able to prioritize ten candidates for conservation. The first focus of their expertise was the downed marble marker for Oliver Gorham, in Section A. “Just an easy ‘set it up again,’ right?” Not so.

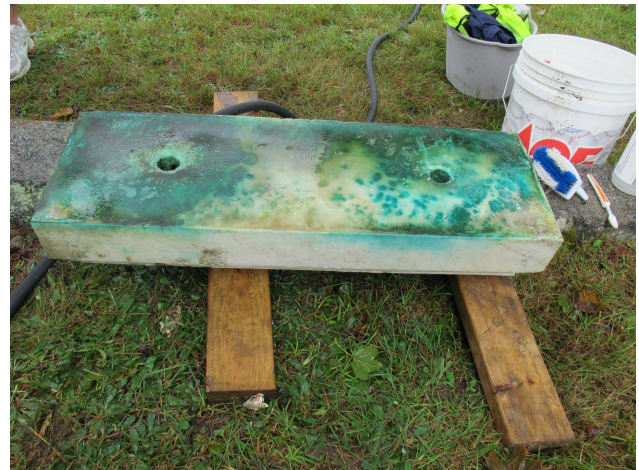
Unfortunately, the bronze pins, used to connect all three stone components (in-ground granite base, marble base/plinth, and the pointed Gothic arch top) were broken off and deeply embedded in the marble top element and not likely to be successfully removed. (The greenish stain that remains on the plinth results from the deterioration of the bronze pins and the breakdown of their copper content.) Since the existing pin holes in the granite base and marble base were clear, it was decided to re-align the bases using two new fiberglass pins. To set the top element, matching holes were drilled in the top center of the marble

base and the exposed bottom of the arched-top gravestone itself to receive a single pin. Connecting surfaces were cleaned, carefully measured, and an epoxy adhesive placed into each drill hole and the pins inserted into the adhesive in the granite base. The middle marble base was placed onto two 1” mahogany blocks and setting compound placed around the perimeter of the

base. 1/8” thick plastic setting cushions were placed between the two bases and the marble base was carefully lowered onto the compound. Adhesive was placed in the holes in the marble base to affix the pins. Excess setting compound that squeezed out from between the bases after the marble base was lowered was removed. A tripod hoist lifted the arched top into position to be carefully guided onto the newly drilled waiting central pin. Again a roll of setting compound and 1/8” setting cushions were placed on the top of the outer edge of the marble base where the arched top would descend, effectively using the weight of the heavy stone to assure a good seal. As before the excess squeezed out by the heavy top element was removed. This provides a “gasket” to prevent moisture from accumulating, freezing, and altering the repair. The first rescued stone was standing proud!

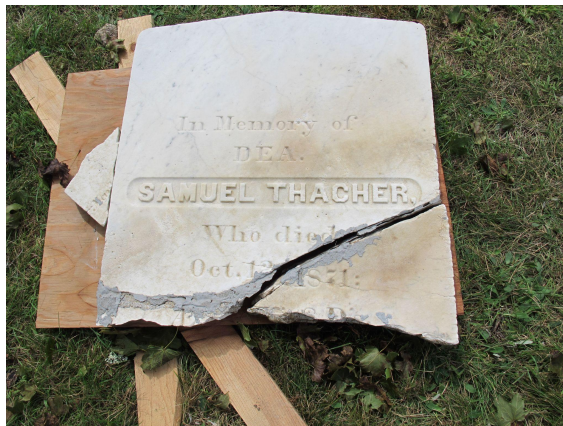
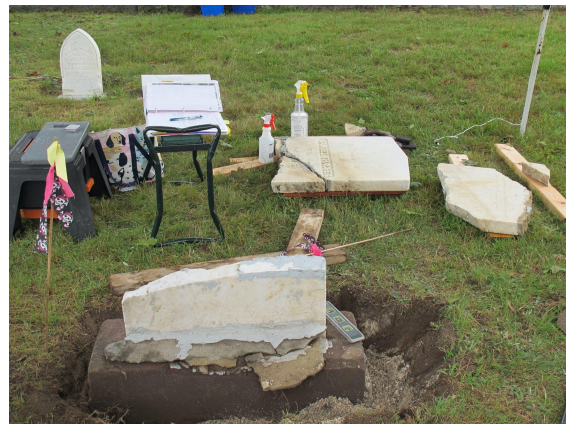
Sanuel Thacher’s shattered stone will need to be worked on in stages over time. The base has now been cleaned, reset on a sand and pea stone foundation, leveled, and ready to receive the six stone pieces that will be affixed, pinned where necessary, voids filled, and eventually set up as one intact piece.
