48 PRESERVATION BRIEFS

Preserving Grave Markers in Historic Cemeteries

Mary F. Striegel, Frances Gale, Jason Church, & Debbie Dietrich-Smith

Technical Preservation Services

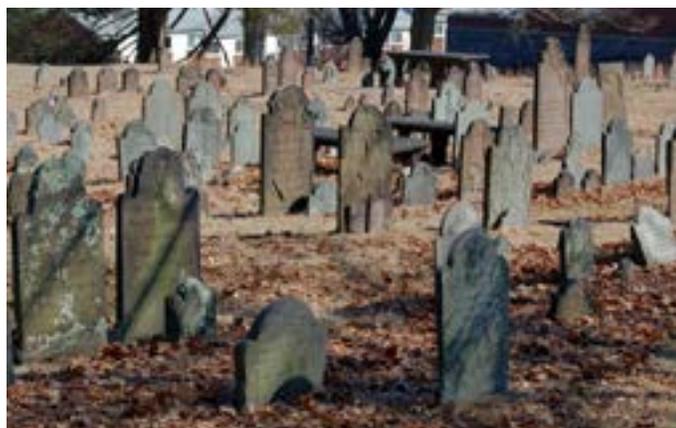
Figure 1. Sandstone and slate grave markers in the Ancient Burying Ground in New London, CT, display a variety of weathering conditions. Markers in the cemetery date from the mid-17th to the early 19th centuries. Photo: Jason Church.

While cemeteries are often considered to be perpetual, their most prominent feature—the grave markers—are not. They weather, naturally decay, often are poorly maintained and repaired and, on occasion, are vandalized (Fig. 1). Grave markers are usually noteworthy not only for their inscriptions but also for their craftsmanship. Exceptional markers are considered works of art.

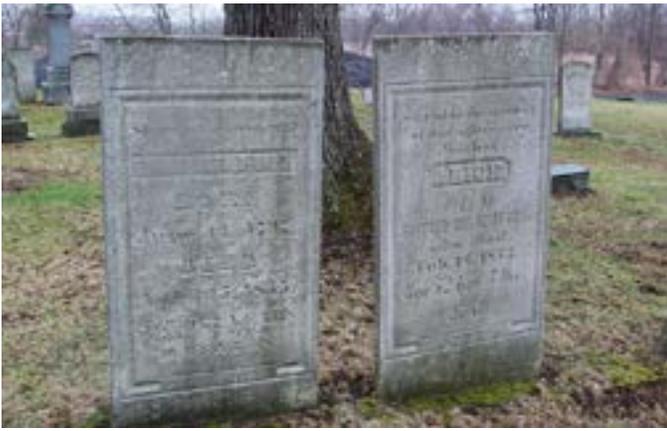
Figure 2. These mid-19th century, single-element stone grave markers in the Grove Cemetery in Bath, NY, are set in a vertical position. Photo: Jason Church.

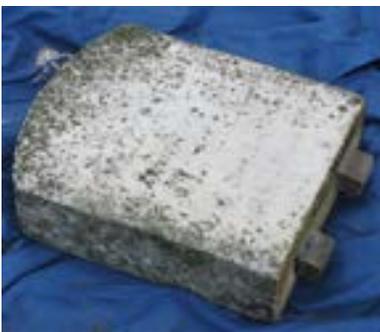
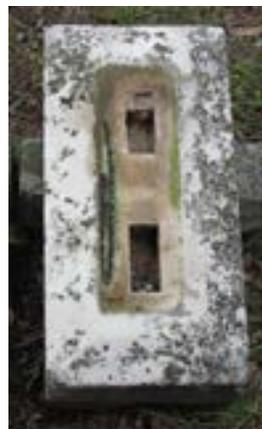
Figure 3. A multi-element grave marker from the early 19th century in the St. Michael’s Cemetery, Pensacola, FL, consists of a vertical element with tabs (left image) into a slotted base (right image). Photo: Fran Gale.

slot” grave marker, the tabbed upper stone was set in a slotted base (Fig. 3). More common today, the upper headstone is secured with a technique that uses small spacers set on the base and a setting compound. This technique or one that uses an epoxy adhesive may be found on older markers where the stones have been reset.

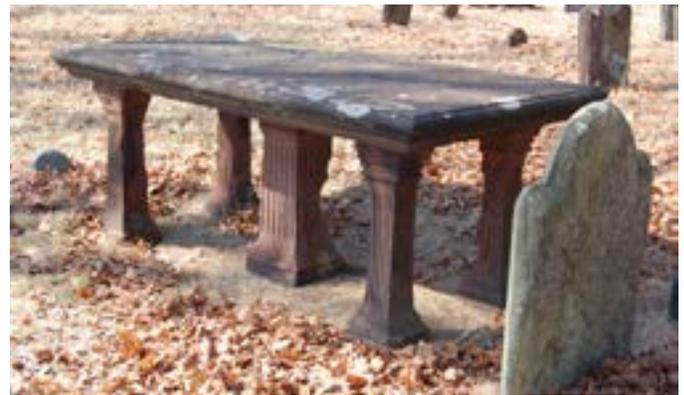
Figure 4. This sandstone table tomb, located in Cedar Grove Cemetery, New London, CT, is an engineered grave marker structure consisting of a horizontal stone tablet supported by four vertical table “legs” with and a central column,. Photo: Jason Church.

Grave markers can also be engineered structures. Examples of grave marker structures include masonry arches, box tombs, table tombs, grave shelters, and mausoleums (Fig. 4). The box tomb is a rectangular structure built over the gravesite. The human remains are not located in the box itself as some believe, but

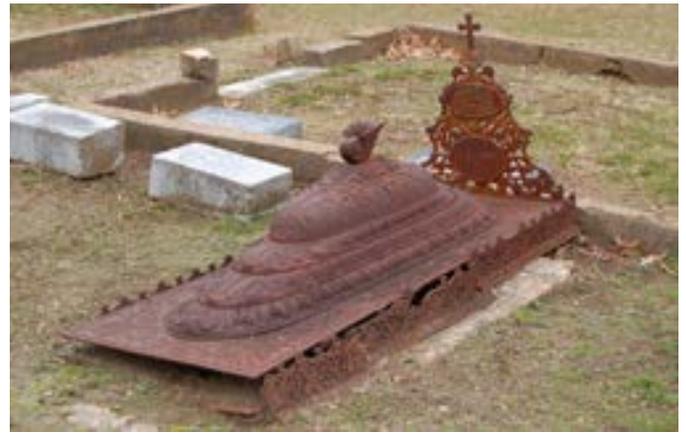
Figure 6. Decorative cast-iron grave markers like this late-19th century one in Oakland Cemetery in Shreveport, LA, are produced by heating the iron alloy and casting the liquid metal into a mold. Photo: Jason Church.

Metals are solid materials that are typically hard, malleable, fusible, ductile, and often shiny when new (Fig. 6). A metal alloy is a mixture or solid solution of two or more metals. Metals are easily worked and can be melted or fused, hammered into thin sheets, or

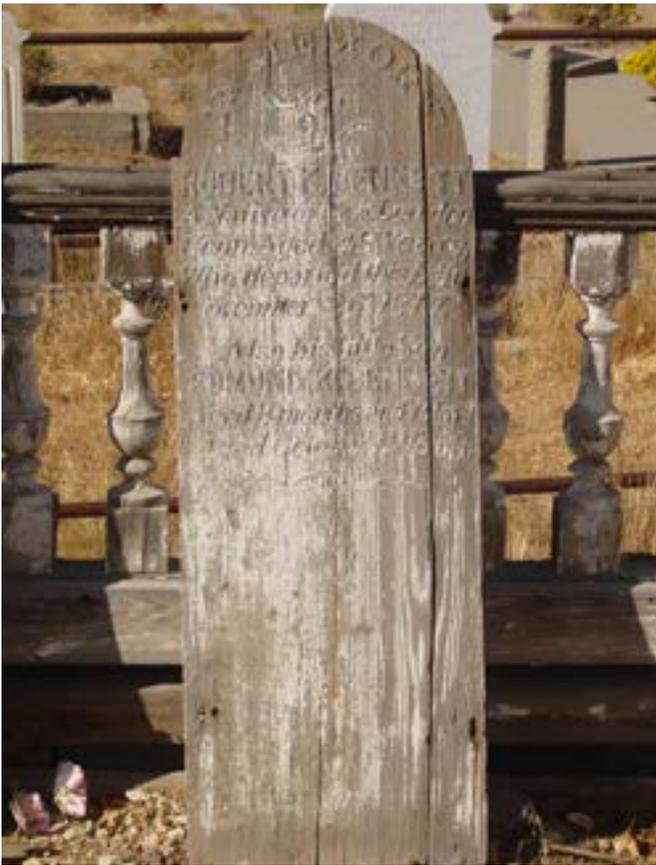
Figure 7. As shown by this 1877 marker in Silver Terrace Cemetery, Virginia City, NV, exposure to sunlight can damage wood grave markers, making the wood more susceptible to water damage and cracking. Photo: Jason Church.

and characteristics of these cells determine the wood's appearance and influence wood properties. Wood-cell walls and cavities contain moisture. Oven drying reduces the moisture content of wood. After the drying process, the wood continues to expand and contract with changes in moisture content. The loss of water from cell walls causes wood to shrink, sometimes distorting its original shape (Fig. 7).

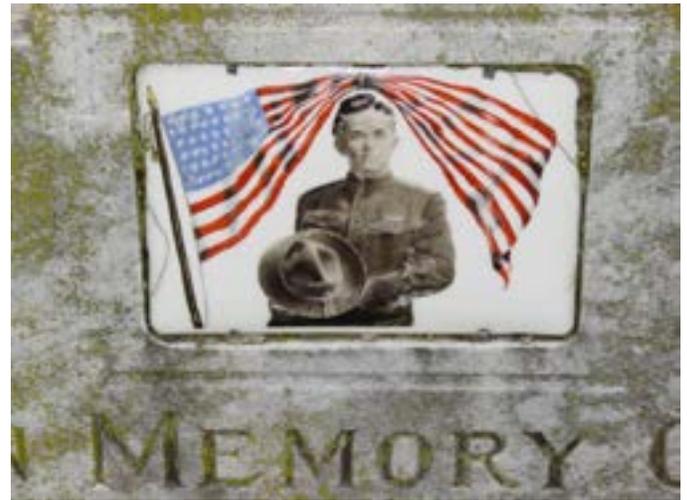
Figure 8. A fired ceramic, this cameo is set in a marble grave marker, located in Elmwood Cemetery, Memphis, TN. Different materials may require different conservation approaches. Photo: Mary Striegel.

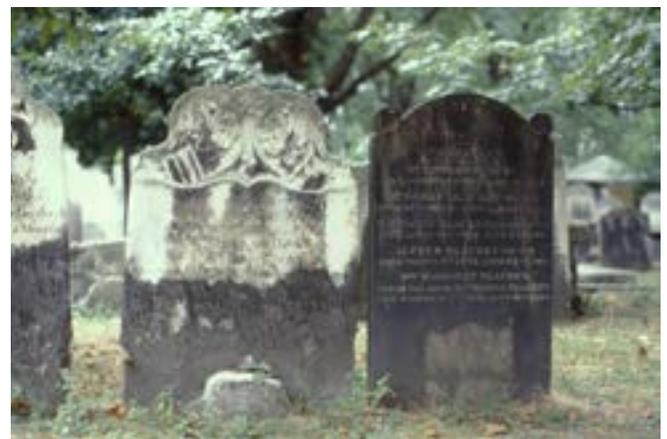
Figure 9. The limestone and sandstone grave markers in this historic cemetery have different weathering processes. On the left, the limestone shows surface loss in areas exposed to rainwater and gypsum crust formation below. The sandstone marker on the right displays uniform soiling, but surface hardening may be occurring. Photo: Fran Gale.

All grave marker materials deteriorate when they are exposed to weathering such as sunlight, wind, rain, high and low temperatures, and atmospheric pollutants (Fig. 9). If a marker is composed of several materials, each may have a different weathering rate. Some weathering processes occur very quickly, and others gradually affect the condition of materials. Weathering results in deterioration in a variety of ways. For example, when exposed to rainwater some stones lose surface material while others form harder outer crusts that may detach from the surface.

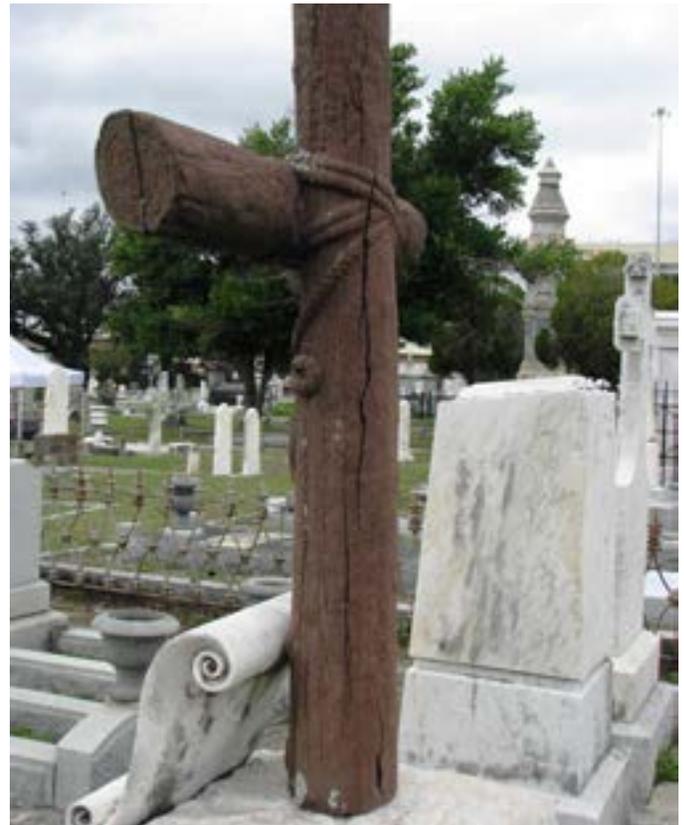
Figure 10. The sandstone cross (carved to look like wood) in this grave marker in St. Michael's Cemetery in Pensacola, FL, provides an example of inherent vice – the severe delamination affecting the sandstone has occurred along its natural bedding planes. Photo: Fran Gale.

The term “inherent vice” is used to describe a material with a naturally occurring problem that leads to premature deterioration (Fig. 10). An example of this problem is marble that has cracked due to natural locked-in stresses. Inherent vice also describes grave markers that are composed of incompatible materials, where decay is accelerated in one or both materials because of chemical interactions caused by their close proximity. An example is the galvanic corrosion that occurs when dissimilar metals, such as copper and iron, are in contact and exposed to moisture.

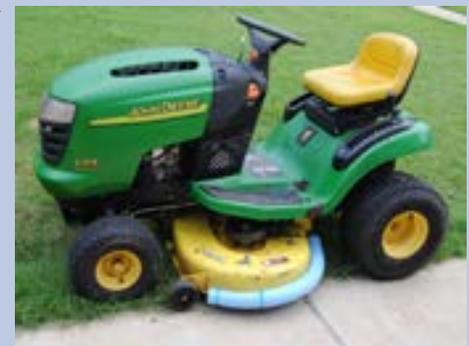
Figure B. A pool ‘noodle’ can be fitted to the deck of a lawnmower to prevent damage to grave markers. Photo: Debbie Dietrich Smith.

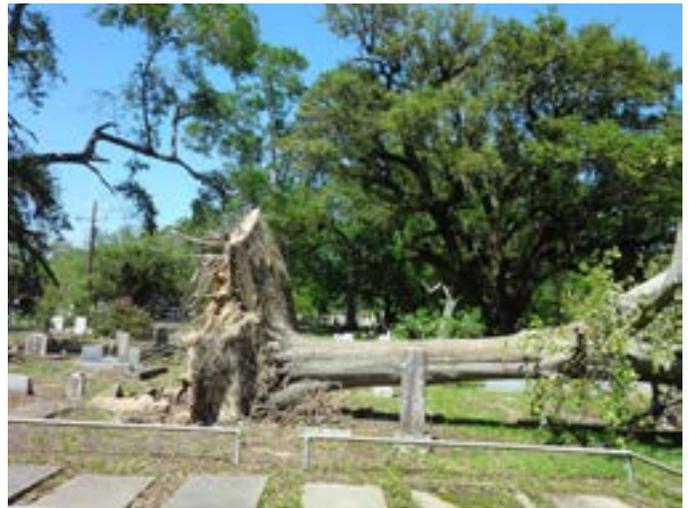
Figure 11. Woody vegetation can damage grave markers and pose a risk to visitors unless well managed and maintained. Photo: Jason Church.

Woody vegetation can damage grave markers in a variety of ways (Fig. 11). Trees, bushes, and vines can shade grave markers, extending the time that the markers are exposed to moisture. Tendrils and roots may burrow into mortar joints and openings, causing mechanical damage and large plants may lift up or shift markers. Even leaves and twigs, when allowed to collect on the ground near grave markers, can affect water drainage and evaporation (Fig. 12).

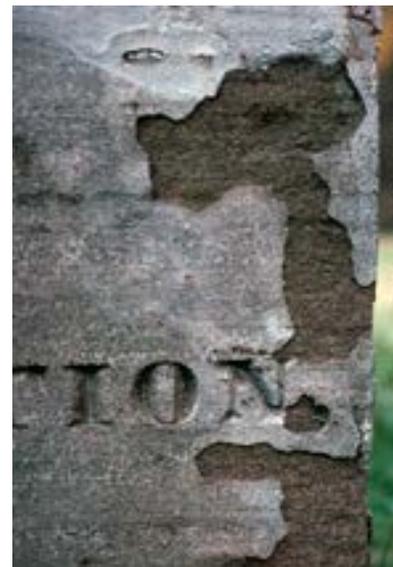
Figure 13. The impervious coating used to "protect" this sandstone grave marker trapped moisture within the stone, eventually resulting in deterioration and surface loss. Photo: Fran Gale.

Repointing masonry grave markers using Portland cement mortars that are harder than historic mortars often results in accelerated deterioration of the masonry material. Mortar should be softer than the adjacent masonry, enabling trapped moisture to migrate out, and serve as the sacrificial material when cracking occurs to relieve excessive stress. Problems also result when using impervious "protective" coatings that can trap moisture within the masonry, resulting in damage during wet/dry and freeze/thaw cycles (Fig. 13).

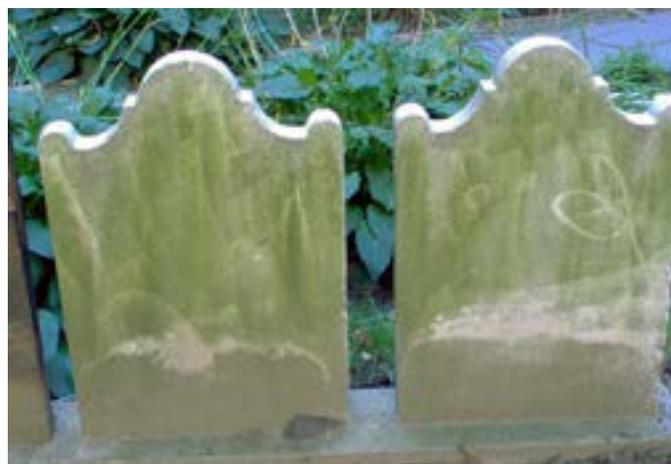
Figure 14. High-pressure water washing can damage grave markers. The photograph shows "wand marks" on the headstones produced by inappropriate pressure washing. Photo: Jason Church.

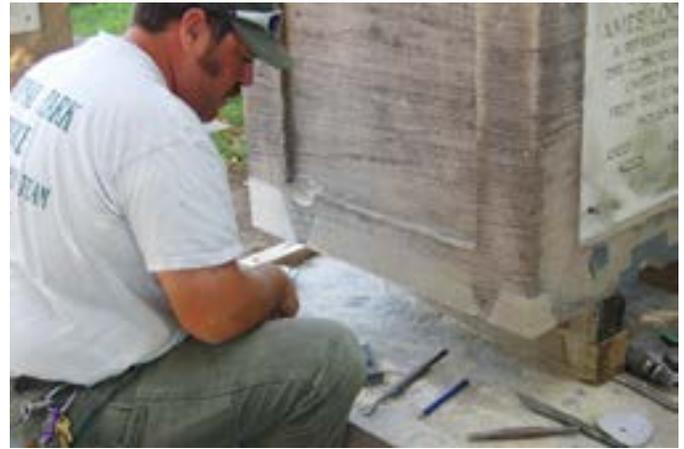
Figure 16. A professional mason works to insert a new piece of stone. Often referred to as a “dutchman”, this repair technique requires replacing the deteriorated stone section with a new finished piece of the same size and material. Photo: Jason Church.

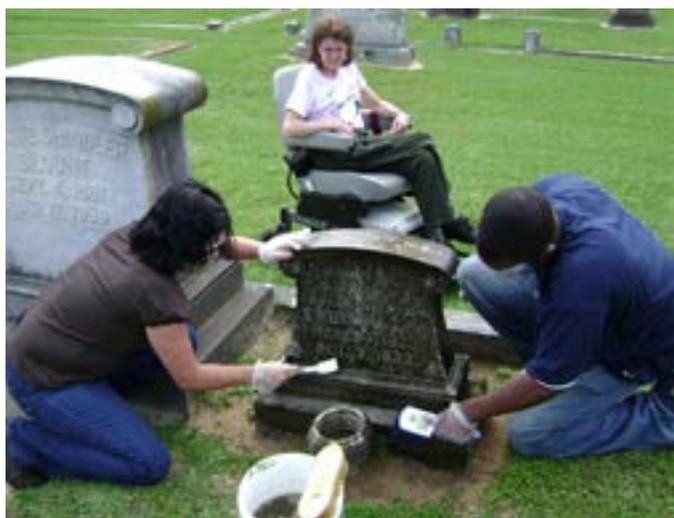
Figure 17. Volunteers can undertake cleaning of grave markers once they have received initial training. Cleaning methods may include wetting the stone, using a mild chemical cleaner, gently agitating the surface with a soft bristle brush, and thoroughly rinsing the marker with clean water. Photo: Jason Church.

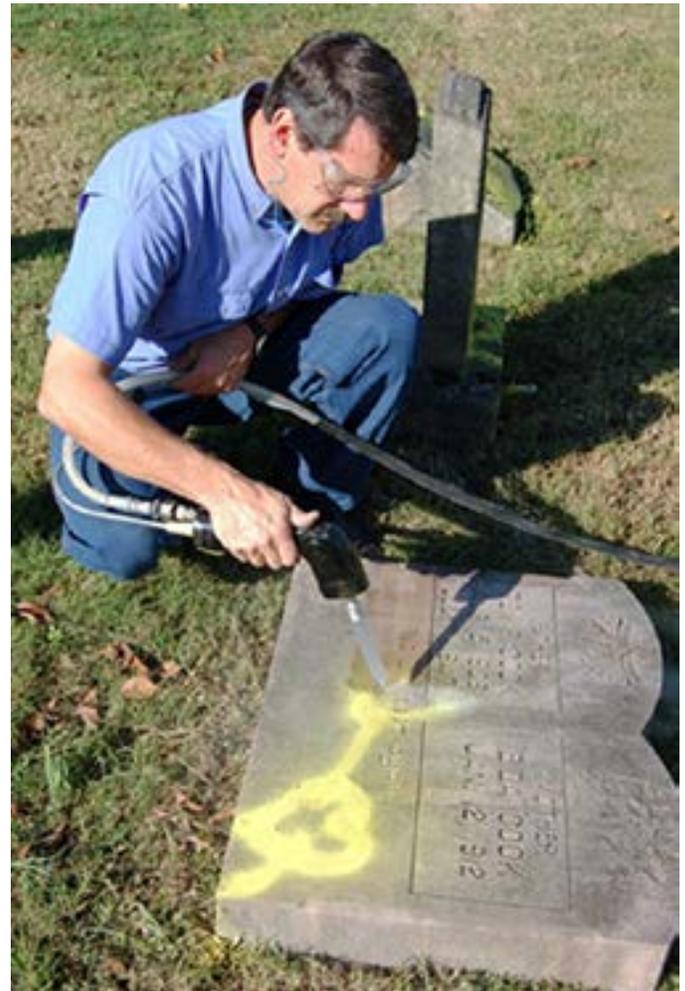
Figure 18. Graffiti is carefully removed using a low-pressure dry-ice misting instrument. Photo: Jason Church.

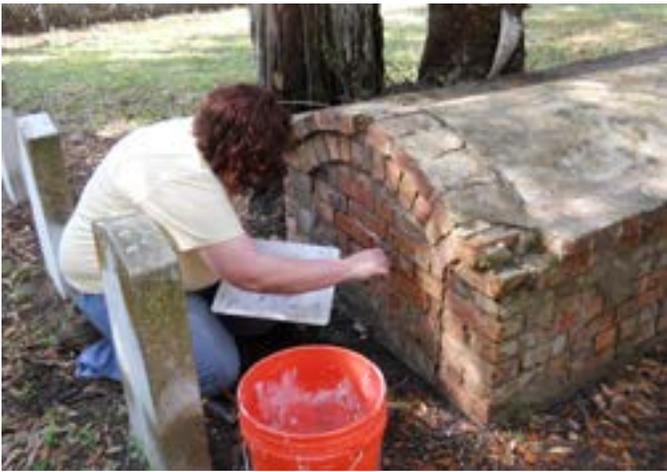
Figure 19. Masonry markers like this box tomb may require the repointing of mortar joints. It is important to use a mortar that is softer than the historic brick. In this case a conservator uses a lime putty-based mortar to repoint. Photo: Jason Church.

Missing and deteriorated mortar in old cemetery grave markers is a common condition, and the mortar should be replaced to prevent water intrusion and potential damage (Fig. 19). Several questions should be considered when selecting materials for repointing. Most importantly, what is the masonry substrate that

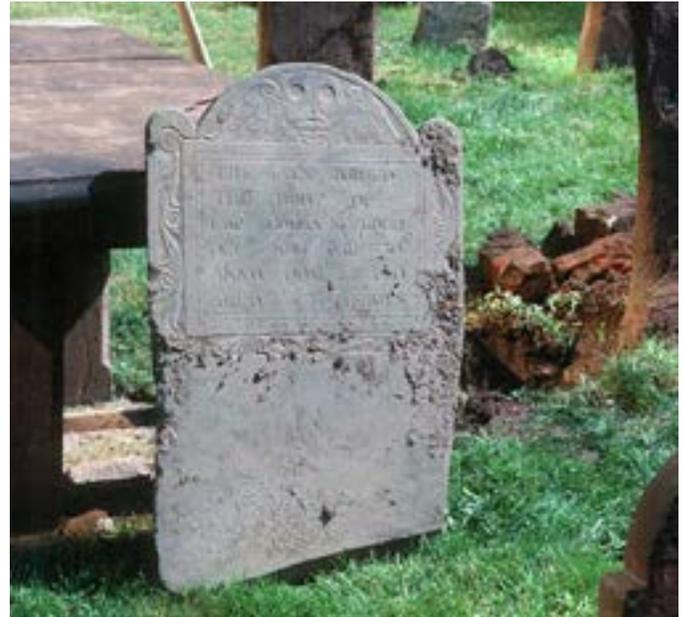
Figure 20a. This slate grave marker in the Ancient Burying Ground in Hartford, CT, is a ground-support stone. Resetting requires digging a hole that will hold the base of the stone and then compacting the soil at the bottom of the hole by hand. Photo: Fran Gale.

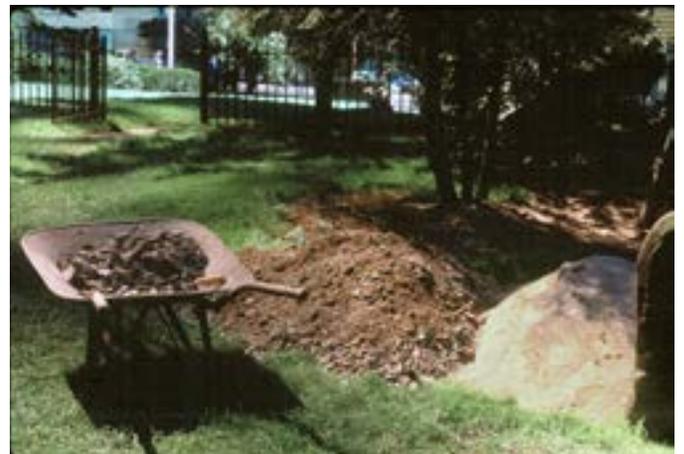
Figure 20b. To facilitate drainage, crushed stone, gravel, and sharp sand line the hole and are hand-tamped around the stone after placement. Photo: Fran Gale.

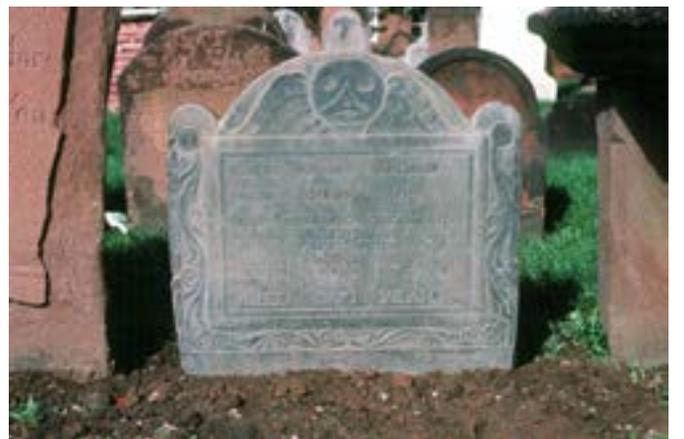
Figure 20c. The reset ground-supported grave marker should be level and plumb. Photo: Fran Gale.

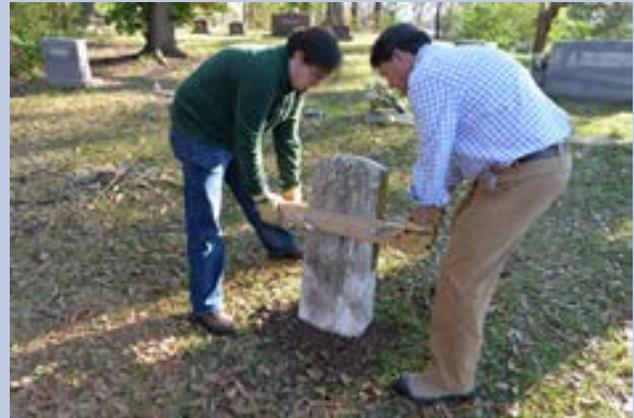
Figure E1. The simple wooden clamp system allows two people to safely lift a marble grave marker. Photo: Sarah Jackson.

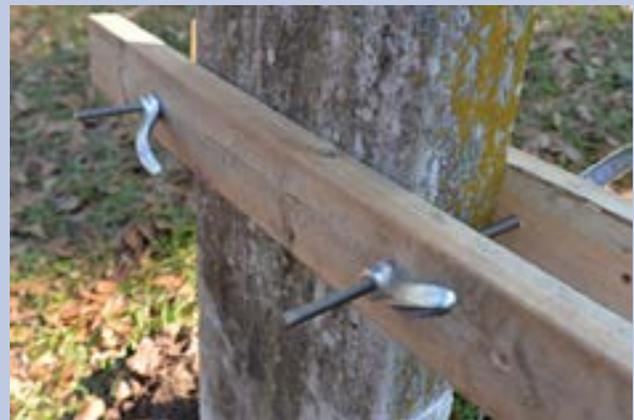
Figure E2. The clamp system is constructed from off-the-shelf wooden boards. Photo: Sarah Jackson.

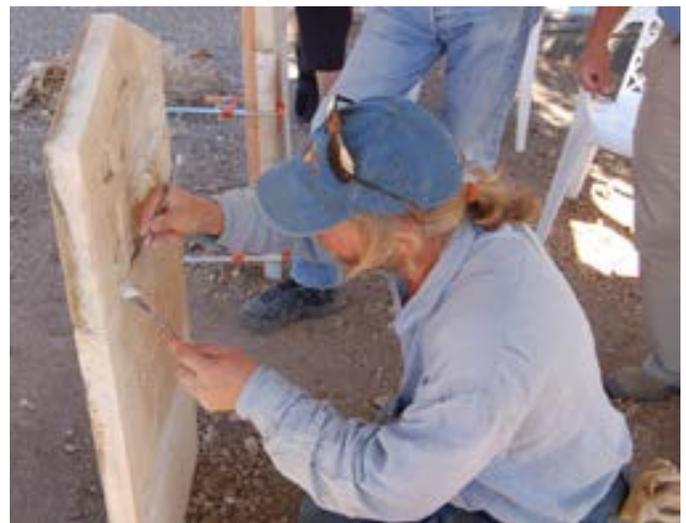
Figure 21. Cracks in a stone marker should be filled to keep water and debris out and prevent the crack from becoming larger. A patching mortar is designed to be used, in this case, with historic marble. Photo: Mary Striegel.

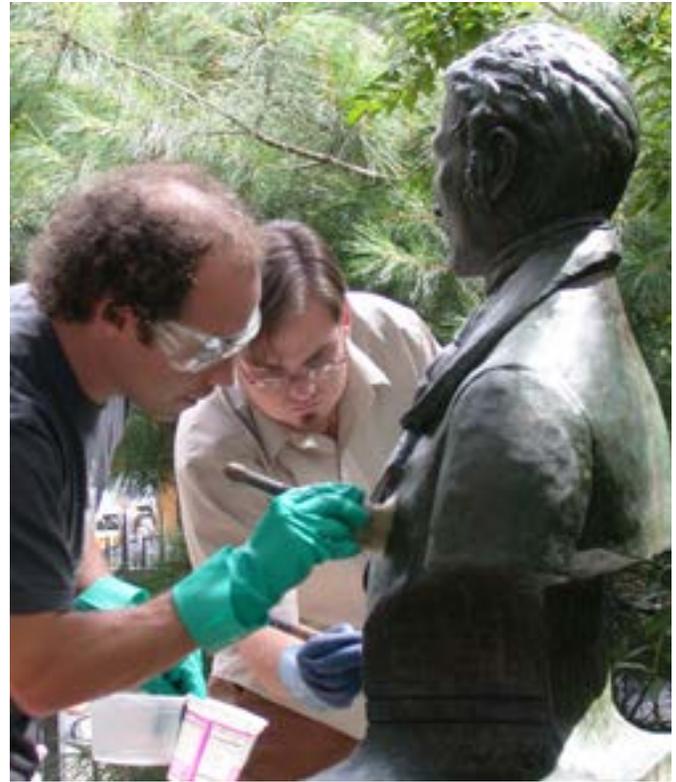
Figure 22. A protective coating must be maintained on metal elements. Wax or lacquer coatings help preserve the bronze patina and slow corrosion. Conservators apply a microcrystalline wax to this bust at St. Mark's Church in-the-Bowery, New York, NY. Photo: John Scott.

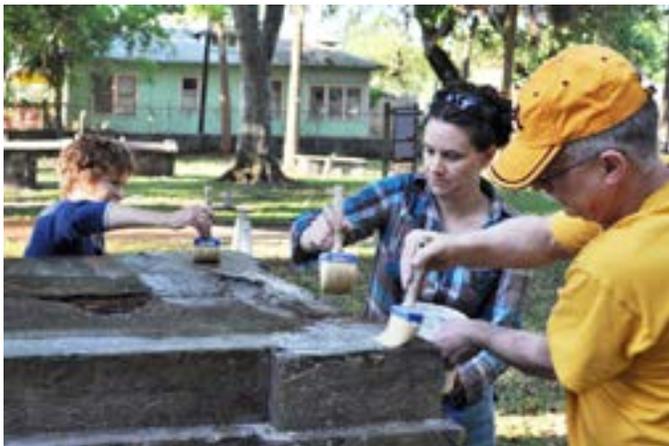
Figure 23. Limewash is a breathable coating sometimes used to protect the surface of the grave marker and provide a decorative finish. Limewash is applied by brush in five to eight thin coats (with each coat about the consistency of skim milk). The surface is allowed to slowly dry between coats. Sometimes the surface is covered by damp burlap to slow the drying process. Photo: Sarah Jackson.

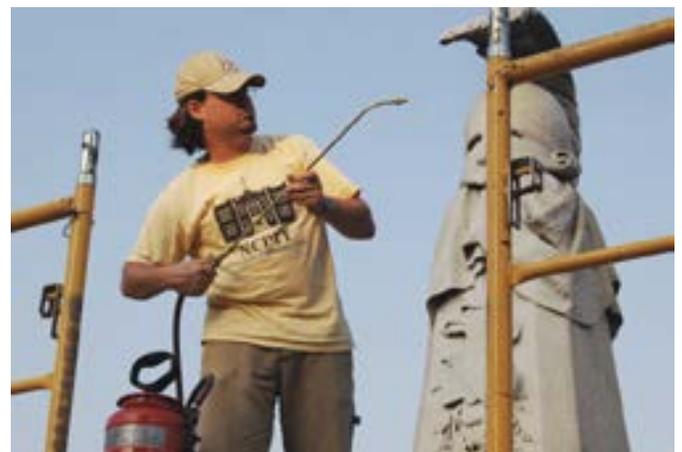
Figure 24. A severely deteriorating monument or grave marker can be treated with a stone consolidant. The treatment is usually applied using a spray system. The consolidant soaks into the stone and replaces mineral binders that hold the stone together. On-site and laboratory testing and evaluation are performed prior to using this non-reversible type of treatment. Photo: Lucas Flickinger.
