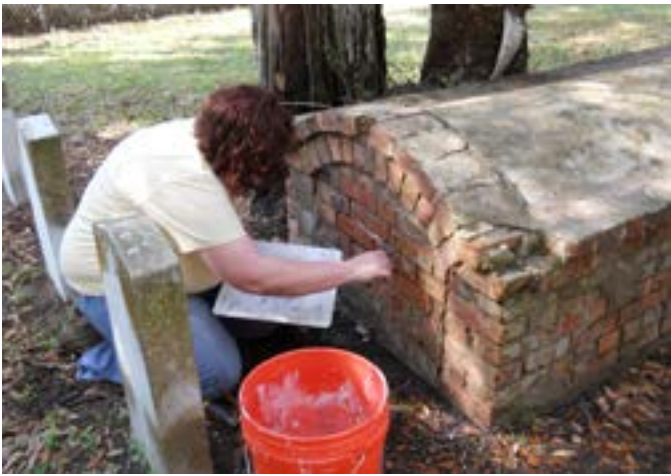
Figure 19. Masonry markers like this box tomb may require the repointing of mortar joints. It is important to use a mortar that is softer than the historic brick. In this case a conservator uses a lime putty-based mortar to repoint. Photo: Jason Church.

requires repointing? What mortar mix is suitable for the historic masonry? How quickly will mortar need to cure? Soft mortars contain traditional lime putty or modern hydrated lime. Harder mortars contain natural or Portland cement. If necessary, mortars can be tinted with alkali-stable pigments to match historic mortar colors. The selection of the mortar to be used is critically important to the success of the project. An inappropriate mortar can result in unattractive work and accelerate the deterioration of the historic grave marker. Always avoid the use of bathtub caulk and silicone sealants for repointing mortar joints.

Prior to repointing, any loose and deteriorated mortar needs to be removed from the joint, preferably using hand tools. Following joint preparation, the mortar materials (lime, cement, and sand) are mixed, and then water added to form a stiff paste. The repointing mortar is applied using a tuck pointing trowel, typically with a narrow 1/8"- 1/2" flat blade. Mortar is compacted into the joint, and then excess mortar is removed and the original joint profile replicated. Good repointing requires skill. Generally, a mason or person with masonry training should repoint mortar joints.

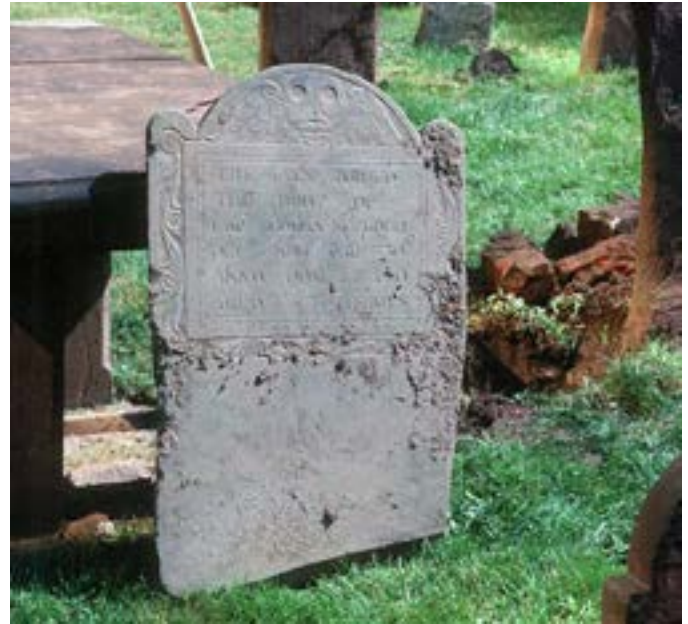
Figure 20a. This slate grave marker in the Ancient Burying Ground in Hartford, CT, is a ground-support stone. Resetting requires digging a hole that will hold the base of the stone and then compacting the soil at the bottom of the hole by hand. Photo: Fran Gale.

Resetting is recommended for grave markers when their foundations are unstable or out of plumb (Figs. 20a through 20c). This often complex activity involves lifting the grave marker, leveling its foundation, and returning the marker to its original upright position. Workers can be injured and the grave marker damaged if resetting is not carried out properly and safely.

The hole left from removal of the marker will need to be enlarged to hold the base of the stone. Soil at the bottom of the hole should be compacted by hand, not with a power tamper. In most cemeteries, crushed stone or sharp pea-size gravel mixed with angular sand can be used to line the hole and then hand-tamped around the stone after it is placed in the hole. The gravel helps facilitate drainage and keeps the stone from settling. A bubble level can be used to ensure that the stone is plumb. Markers should not be set in concrete.

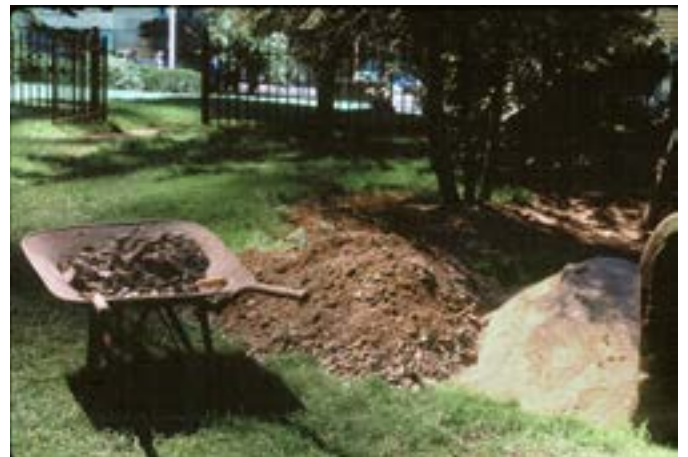
Figure 20b. To facilitate drainage, crushed stone, gravel, and sharp sand line the hole and are hand-tamped around the stone after placement. Photo: Fran Gale.

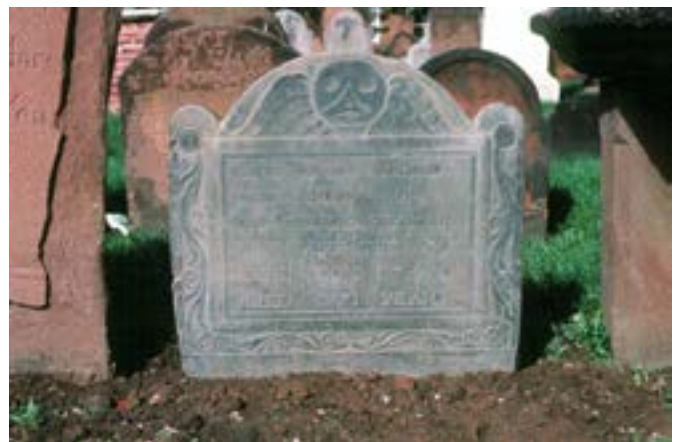
Figure 20c. The reset ground-supported grave marker should be level and plumb. Photo: Fran Gale.

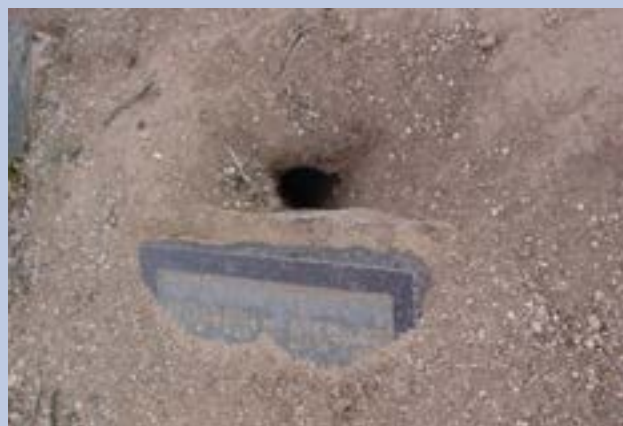
Figure C. Gophers and other burrowing animals produce uneven ground and holes that are trip and falling hazards to visitors and staff of historic cemeteries. Photo: Jason Church.

Trip and falling hazards include uneven ground, holes, open graves, toppled grave markers, fallen tree limbs, and other debris (Fig. C). Sitting, climbing, or standing on a grave marker should be avoided since the additional weight may cause

Burrowing animals like armadillos, groundhogs, gophers, and moles disrupt the ground with their digging and tunnels and can create tripping hazards or undermine grave markers. Prairie dogs have been known to dig up bones and destroy gravesites. Sinkholes created by these animals can also be perfect places for other creatures like snakes to inhabit.

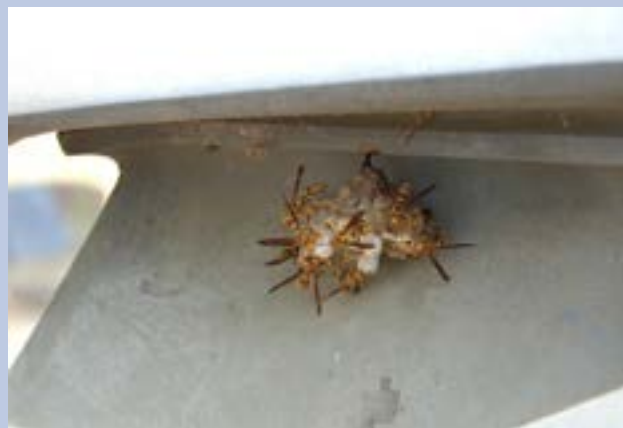
Figure D. Yellow jackets that are nesting below the projecting molding of this grave marker pose a hazard to visitors and staff because, if disturbed, they will vigorously defend their nest. Yellow jacket, paper wasp and hornet nests should be removed from grave markers by trained staff or specialists. Photo: Jason Church.

Snakes, wasps, and burrowing animals inhabit historic cemeteries (Fig. D). Snakes sun on warm stones and hide in holes and ledges, so it is important to be able to identify local venomous snakes. An appropriate venomous snake management plan should be in place, and

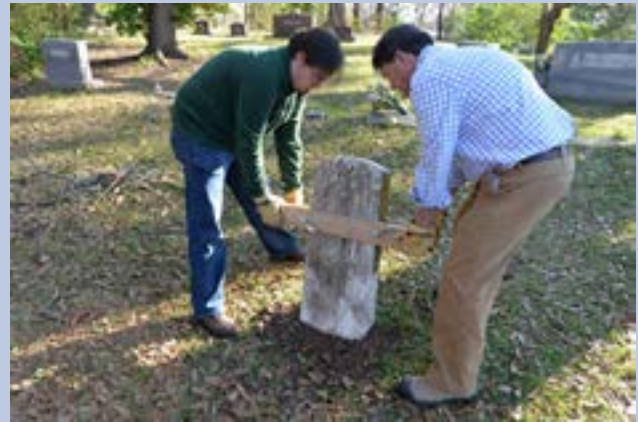
Figure E1. The simple wooden clamp system allows two people to safely lift a marble grave marker. Photo: Sarah Jackson.

lifting techniques. Lift equipment and ergonomically correct tools should be routinely used to lift heavy markers (for most people this includes markers that weight more than 50 pounds). For smaller grave markers, a simple wooden clamp system can be constructed for a two-person lift (Figs. E1 and E2).

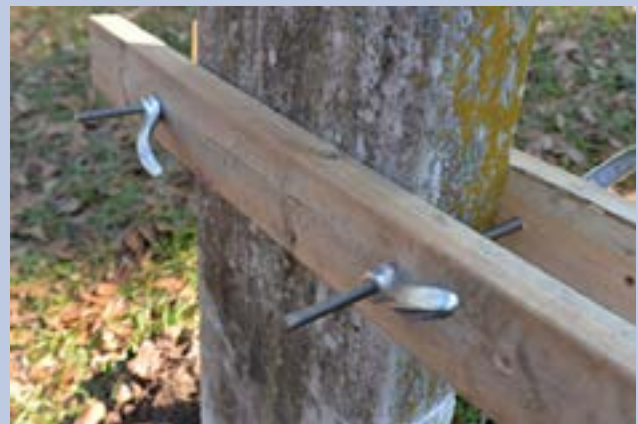
Figure E2. The clamp system is constructed from off-the-shelf wooden boards. Photo: Sarah Jackson.

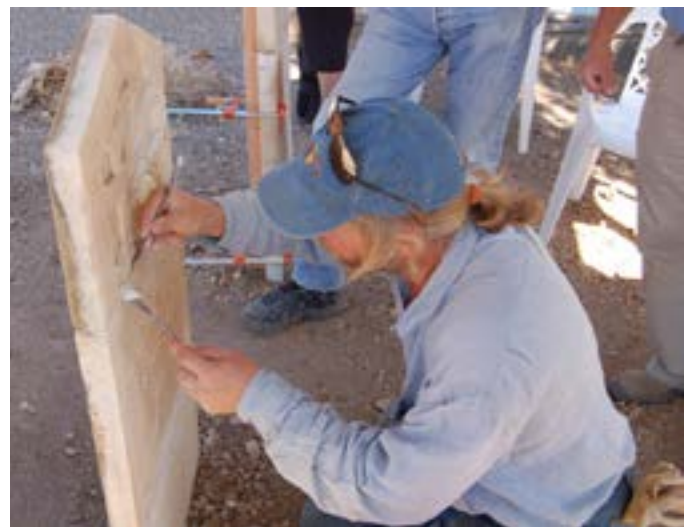
Figure 21. Cracks in a stone marker should be filled to keep water and debris out and prevent the crack from becoming larger. A patching mortar is designed to be used, in this case, with historic marble. Photo: Mary Striegel.

Hairline masonry cracks may be the result of natural weathering and require no immediate treatment except to be photographed and recorded. However, larger cracks often merit further attention. Repairing masonry cracks involves several steps and typically a skilled hand (Fig. 21). The repair begins with the removal of loose material and cleaning. Materials that are used for crack repair include grouts for small cracks and epoxy for large cracks affecting the structural integrity of the monument. Gravity or pressure injection is used to apply grout or epoxy. Crack repair can be messy, so careful planning and experience are helpful. If the crack is active, a change in size of the crack will be noted over time. Active cracks require further investigation to ascertain the cause of the changes, such as differential settlement, and to correct, if possible, the cause prior to repairing the crack.

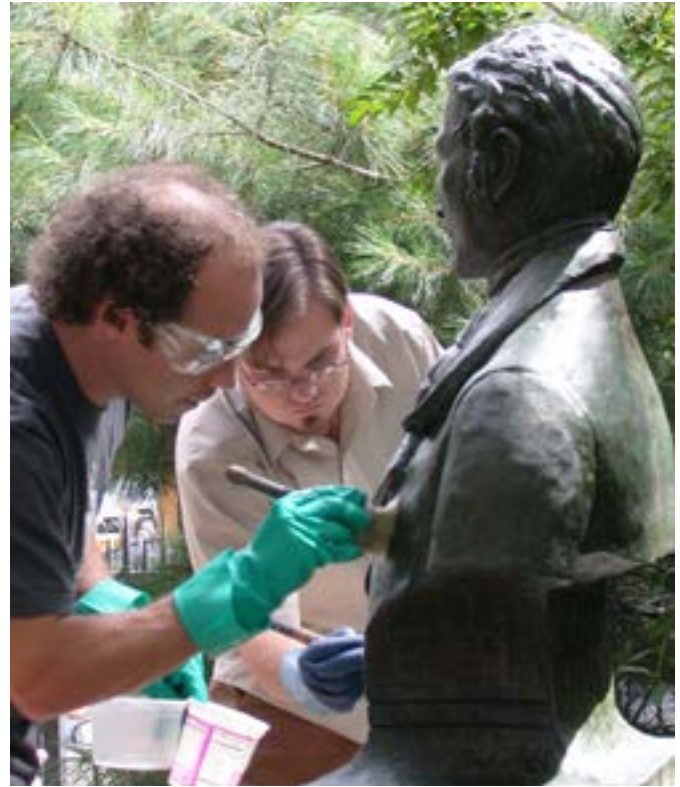
Figure 22. A protective coating must be maintained on metal elements. Wax or lacquer coatings help preserve the bronze patina and slow corrosion. Conservators apply a microcrystalline wax to this bust at St. Mark's Church in-the-Bowery, New York, NY. Photo: John Scott.

Wax coatings are often used for bronze markers (Fig. 22). Wax provides a protective barrier against moisture, soiling, and graffiti. There are several steps in the wax application process. Where there is little corrosion, gentle cleaning of the marker is undertaken prior to applying the wax coating. Apply a thin layer of wax to the marker using a stencil brush or chip brush.

Mineral spirits can be added to the wax to facilitate brush application. A soft, clean cloth is used to remove excess wax and buff the surface. A second coat of wax is sometimes needed.

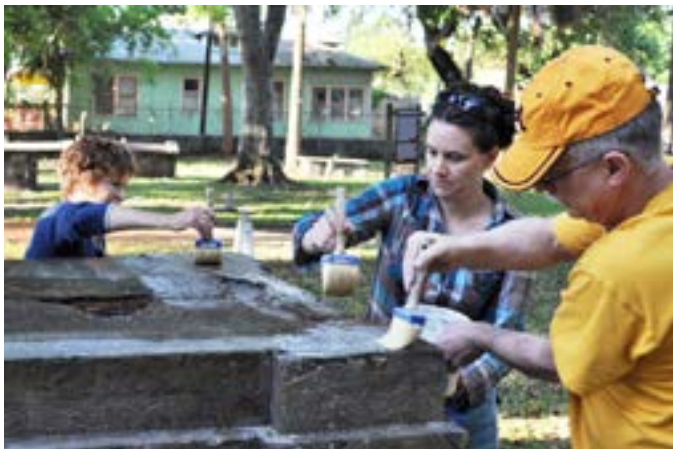
Figure 23. Limewash is a breathable coating sometimes used to protect the surface of the grave marker and provide a decorative finish. Limewash is applied by brush in five to eight thin coats (with each coat about the consistency of skim milk). The surface is allowed to slowly dry between coats. Sometimes the surface is covered by damp burlap to slow the drying process. Photo: Sarah Jackson.

Limewash is a traditional coating that brightens stucco-covered grave markers (Fig. 23). Like paint coatings, it needs to be periodically applied. Limewash is prepared with lime putty or hydrated lime and water. Curing begins following application. The lime putty or hydrated lime reacts with carbon dioxide in the air in a process called carbonation. This reaction eventually forms calcium carbonate, a stable hard coating. Limewash is a “green” coating with no volatile organic compound content and is “breathable,” i.e., it allows for water vapor transmission. Although commonly white, limewash can be colored or tinted with alkali-stable pigments such as iron oxide.

The surface must be cleaned of old coating residues, soiling, and other contaminants. After dampening the surface, the limewash is applied in 5-8 thin coats, allowing each coat to dry between applications. Limewash is translucent immediately after application and then becomes opaque when dry.

Proper curing of limewash is critical to its durability. To prevent premature drying, the treated surface may need to be covered with damp burlap. Limewash must not be applied when frost or freeze conditions are predicted or in temperatures above 90° F. Ideally, limewash should be applied during spring or fall when temperatures are around 70° F, avoiding direct sunlight where possible.

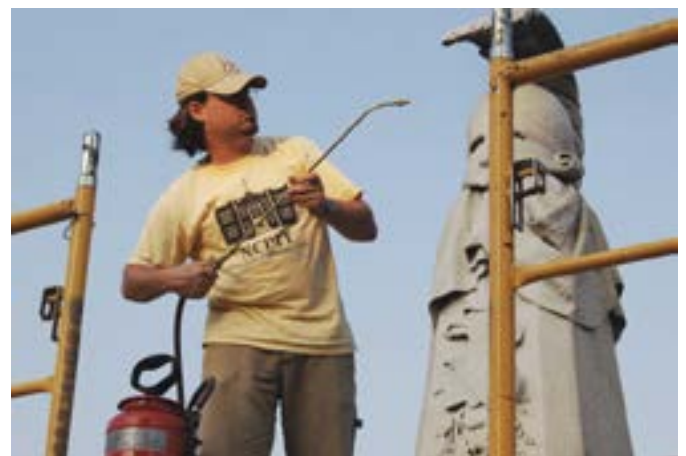
Figure 24. A severely deteriorating monument or grave marker can be treated with a stone consolidant. The treatment is usually applied using a spray system. The consolidant soaks into the stone and replaces mineral binders that hold the stone together. On-site and laboratory testing and evaluation are performed prior to using this non-reversible type of treatment. Photo: Lucas Flickinger.

When erosion is severe, consolidation treatments (e.g., ethyl silicate) have been used to replace mineral binders lost to weathering (Fig. 24). Because these treatments are not reversible, laboratory and on-site testing are essential. Application by a conservator or other experienced preservation professional is advised.
